The Tuning Works

Piston Diagnosis – A rough Guide

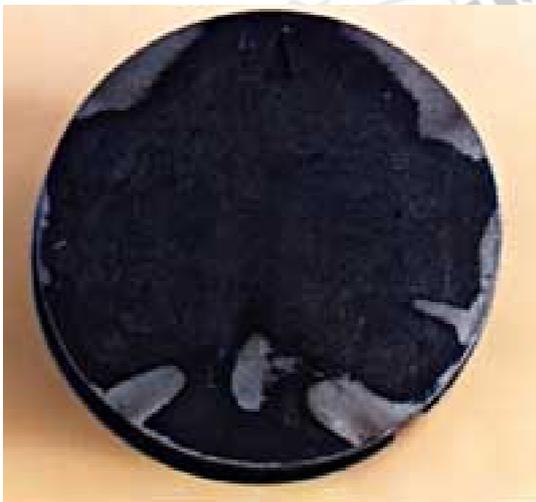
Generally well set up

The crown of the piston shows an ideal carbon deposit pattern. The transfer ports on the engine are flowing evenly and the carbon deposits are a dark chocolate brown colour. This indicates that the bike's engine has been set up and jetted correctly.

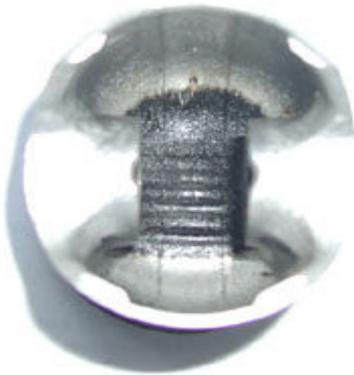
Black spot

Symptom - Underside of the piston has a dark black spot.

Cause - The black spot is a carbon deposit caused by oil burning onto the underside of the piston because the crown was too hot.

Reason - Main reasons for this occurring are overheating due the carbs being jetted too lean, or maybe coolant system failure.

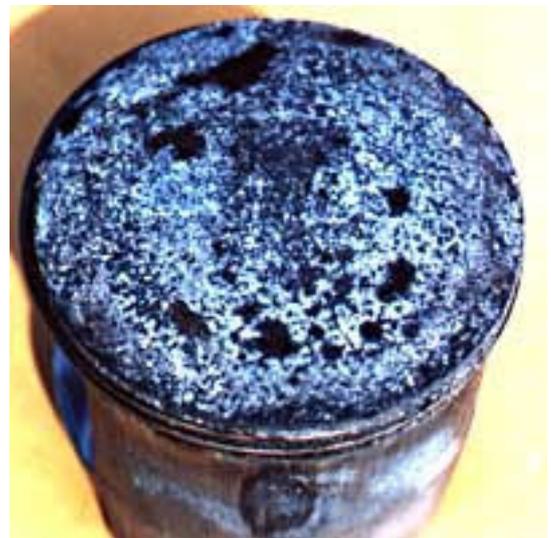
Ash

Symptom - Piston crown is a light grey ash colour.

Cause - This is caused by the engine running too hot. The ash colour is actually piston material that has started to flash melt and turned to tiny flakes. If the engine was left to run much longer it would probably have developed a hot spot and hole on the exhaust port side and then finally failed.

Reason - Main causes are general overheating, the bike being jetted too lean, ignition timing being too far advanced from standard, too much compression for the fuel octane being used Scoring and debris marks.

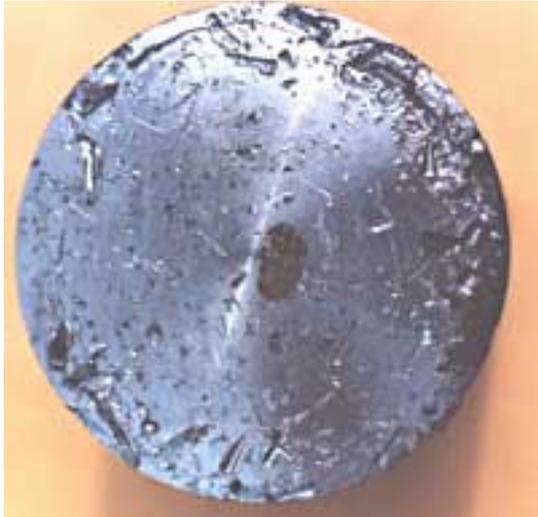
Debris Marks

Symptom - The piston crown and cylinder head show signs of damage where material has been crushed between the two surfaces after entering the combustion chamber. Cause - Most common causes are broken bearings in the big or small end of the con rod, broken rings and dislodged ring centering pins. Reason - Failure to adhere to manufacturers specified service intervals, incorrectly fitted rings, incorrect parts fitted. When this does occur it's extremely important to diagnose the exact cause and trace where the debris has originated from. Crankcases must be stripped and

flushed to remove any remaining debris that could cause the same problem. If the cause was big end failure then the crank must be replaced along with the main bearings and seals.

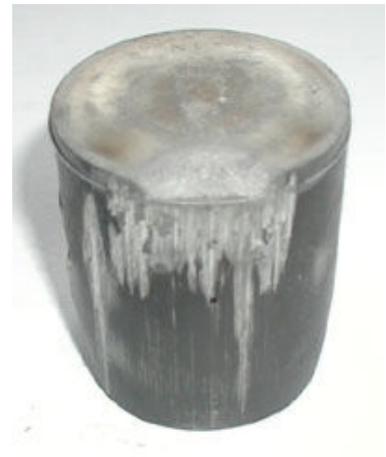
Chipped

Symptom - The piston crown is chipped along the top ring groove.

Cause - Head gasket leak.

Reason - Coolant is drawn into the combustion chamber on the down-stroke of the piston. When the coolant hits the piston crown the change in temperature makes the aluminium brittle and it eventually cracks.

In extreme cases a leaking head gasket can cause erosion at the top edge of the cylinder and the corresponding area of the head. Minor leaks from the gasket or o-ring will also appear as black spots across the gasket surface.

Any engine that is suffering from coolant being forced out of the radiator cap's vent tube suggests a strong indication of a head gasket leak. In most cases the top of the cylinder and the face of the cylinder head must be resurfaced when a leak occurs.

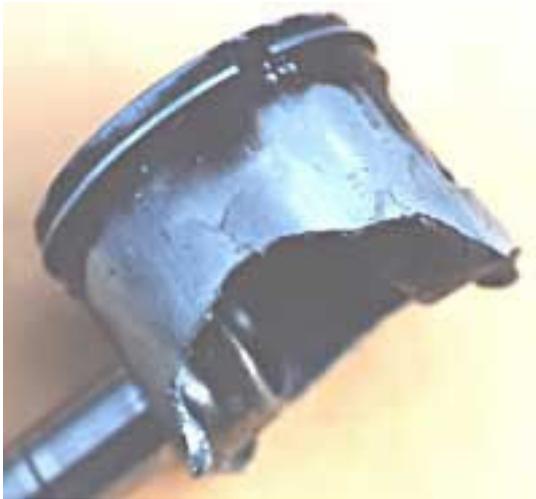
Shattered Skirt

Symptom - Shattered piston skirt.

Cause - Piston to cylinder clearance too large or engine over-revved.

Reason - If the piston to cylinder clearance is too large it allows the piston to rattle inside the cylinder bore, with time the piston develops stress fractures and eventually cracks.

The piston to cylinder clearance should be checked every time you rebuild the top end. To check the clearance measure your cylinder with a bore gauge and micrometer, then measure the piston (in the right place) and check the readings against the limits in your engine's factory service manual. Some people put a feeler gauge down the side; this is less accurate but will give you a "big enough – not big enough" reading.

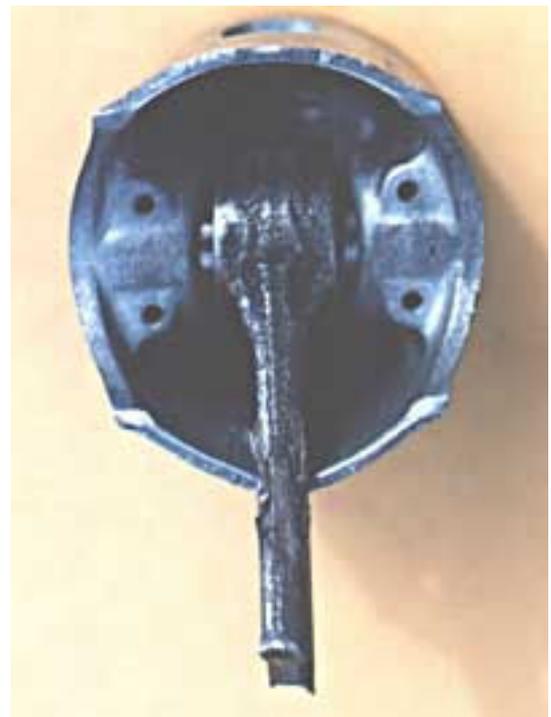
Snapped rod

Symptom - Broken con rod.

Cause - Clearance between the rod and big end thrust washers is too large.

Reason - When the big end bearing wears out the radial deflection of the con rod becomes excessive and the rod suffers from torsion vibration. This leads to breakage of the rod and catastrophic (not to mention expensive) engine damage. Less likely on 'floating big end' engines like the RGV, however still possible.

The big end clearance should be checked every time you rebuild the top end. To check the side clearance of the connecting rod, insert a between the rod and a thrust washer and check the readings against the maximum wear limits in your engine's factory service manual.

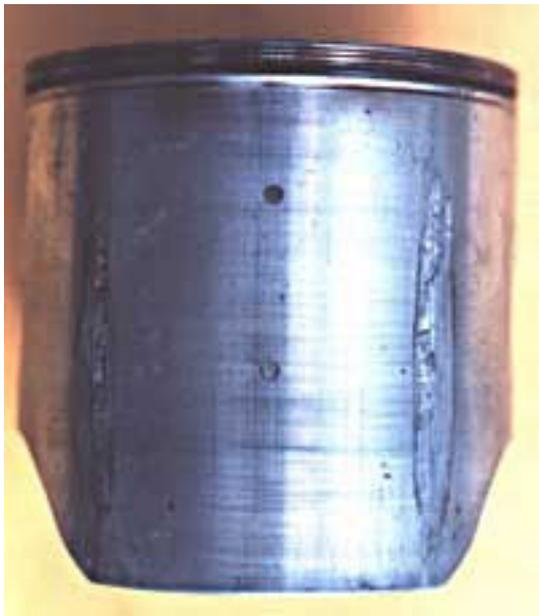
Four corner seizure

Symptom - The piston has vertical seizure marks at four equally spaced points around the circumference.

Cause - A four corner seizure is caused when the piston expands faster than the cylinder and the clearance between the piston and cylinder is reduced.

Reason - The main reasons for this problem are too quick warm-up, too lean carb jetting (main jet), or a spark plug with too high a heat setting being used.

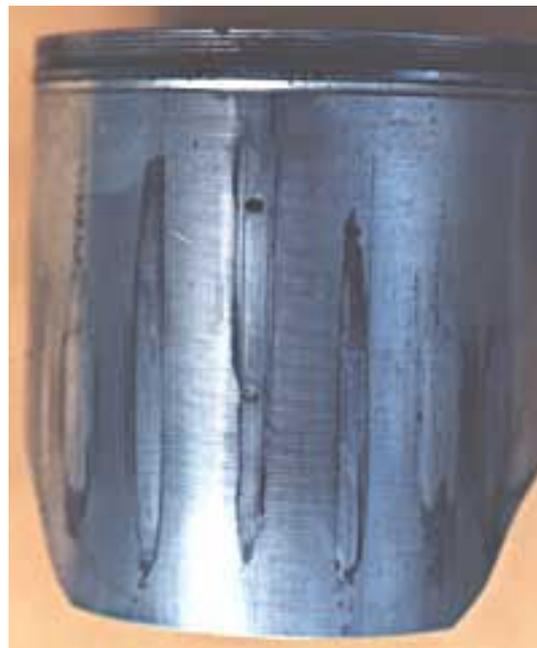
Multi point seizure

Symptom - Piston has multiple vertical seizure marks around its circumference.

Cause - This occurs if mis-matched cylinders and pistons are used, or if a cylinder is replated or bored to a size too small for the piston (that shouldn't happen if you measure!) or the piston was heated too fast expanding quickly before the cylinder is hot enough.

Reason - As soon as the engine is started and the piston started its thermal expansion, the piston pressed up against the cylinder walls and seized.

The optimum piston to cylinder wall clearances for different types of cylinders varies, usually with bore size.

For the best recommendation on the optimum clearance for your engine look to the specs that come packaged with the piston, or consult your factory service manual.

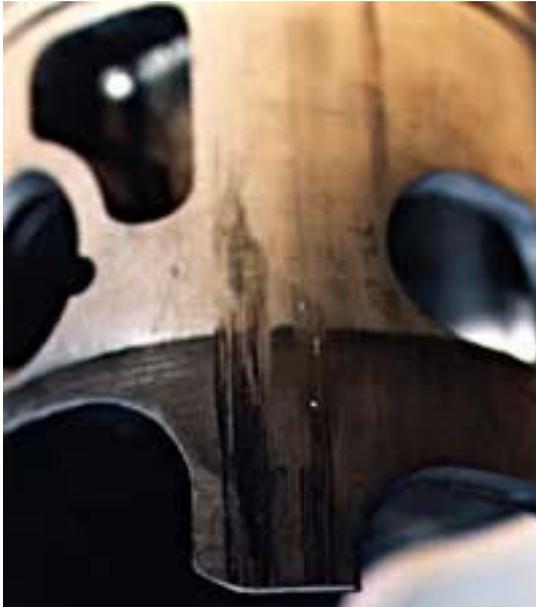
Intake side seizure

Symptom - Piston has seized on the intake side

Cause - There is only ever one cause of a seizure on the intake side and that is loss of lubrication

Reason - Loss of lubrication is down to three things - no pre-mix or two-stroke oil due to incorrect pre-mix ratio being used or oil pump failure/blockage, separation of the fuel and pre-mix oil in the fuel tank, water passing through the air filter and down into the carbs which in turn washes the oil film off the piston skirt.

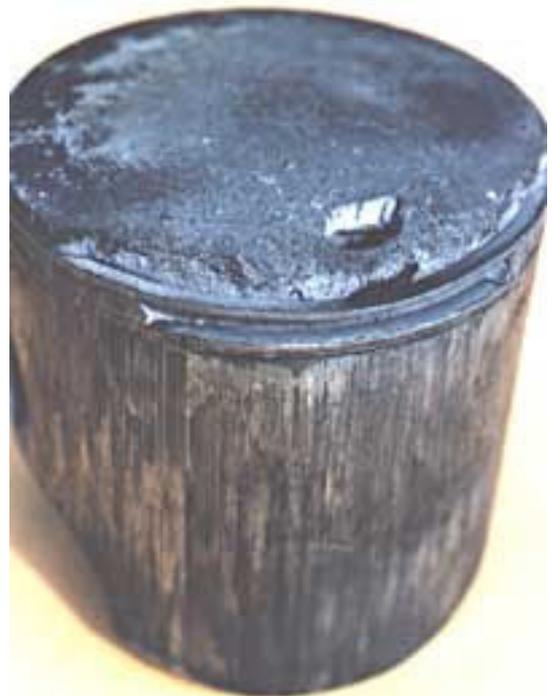
Burn out/blow hole

Symptom - Hole in the piston crown, collapsed ring grooves on the exhaust side

Cause - Piston has severely overheated. As the temperature is higher on the exhaust side problems will appear there first.

Reason - Air leak on the magneto side of the crankshaft seal, too lean carb jetting, ignition timing advanced too far or faulty ignition box, too hot of a spark plug range being used, too high of a compression ratio, or too low octane fuel.

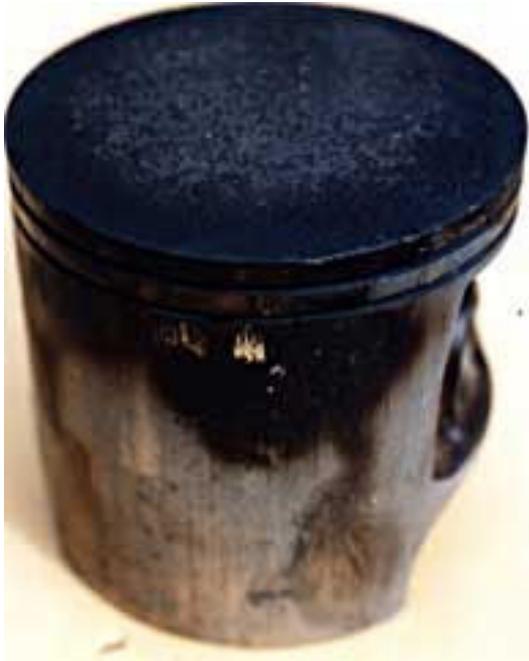
Blow by

Symptom - Deposit on piston skirts

Cause - Piston rings worn past the maximum ring end gap spec, glazed cylinder walls

Reason - This is the most common problem we see. If the rings are worn past the maximum specification they allow combustion chamber gases to seep past the rings and down the piston skirt causing a distinct deposit pattern.

If the cylinder walls are glazed or too far worn the same thing will happen and even fitting new rings will not provide a good enough seal. If in doubt you should send your cylinders to The Tuning Works for inspection and or reconditioning to obtain best performance.
